Manhole Inspection Summary

Manhole # S31GG_065MH

Location Address: **1309 BOLTON ST**

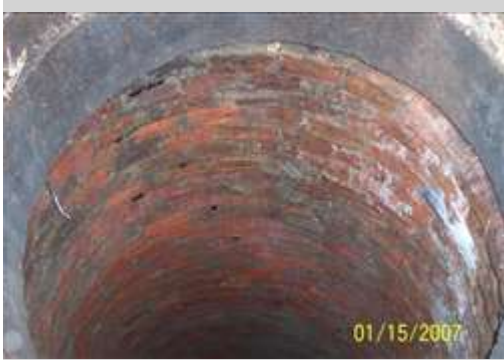
Defect

Bench debris.

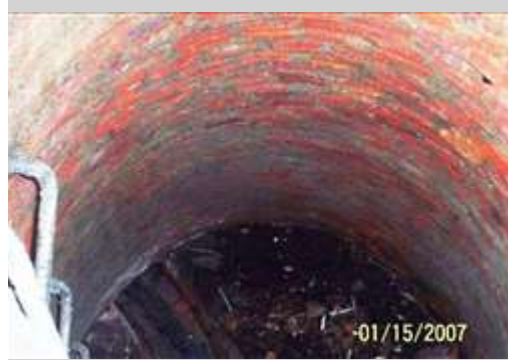
Defect

Frame leaks. Adjustment deterioration, root intrusion and infiltration. Corbel and Barrel infiltration.

Corbel and Barrel infiltration.

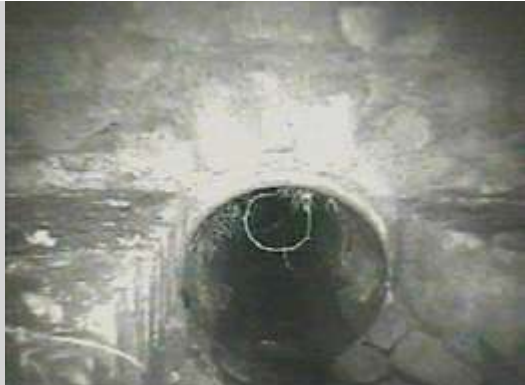
8 in. Circular Gravity Sewer Pipe Out @ 12 O'Clock

Infiltration: **Evidence** Pipe Seal Cond: **Roots**

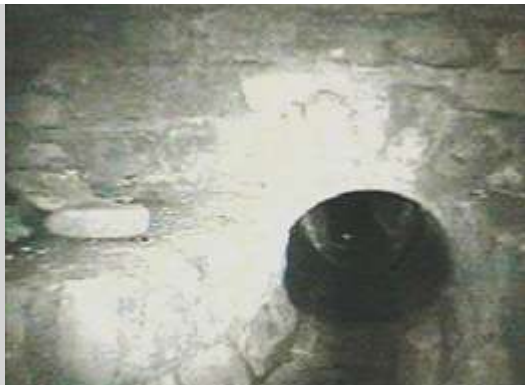
8 in. Circular Gravity Sewer Pipe In @ 3 O'Clock

Infiltration: **Evidence** Pipe Seal Cond: **Unknown**
